**Location:** Buckholt and Cranham Woods

**Water course:** Painswick Stream

**Sub-catchment:** Painswick Valley, Stroud Frome

**STROUD RURAL  
SUSTAINABLE  
DRAINAGE PROJECT**  
NATURAL FLOOD MANAGEMENT  
IN THE STROUD VALLEYS

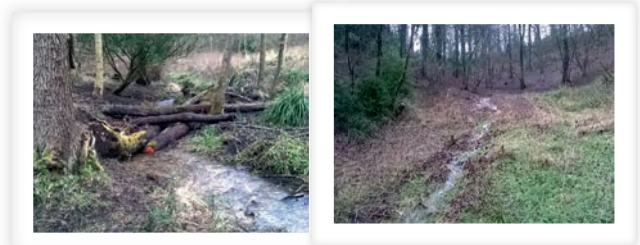
Structures within the NNR were specifically designed to be as natural as possible and to mimic natural tree fall. They are mostly composed of a single beech or ash tree trunk with branches left intact. Trees that had already fallen naturally were pulled into the channel and any cutting necessary was undertaken in-situ. There was no machine access on the NNR so structures were created using a hand winch and crow bar. These structures took three days to build and four volunteers from the AONB Cotswold Wardens worked for a day to help with this work. These structures were not pinned in place.
